Occurrence Description Aircraft Model and Manufacturer: Aeroprakt A32

Occurrence DateTime 23/02/2020 3:50:00 PM

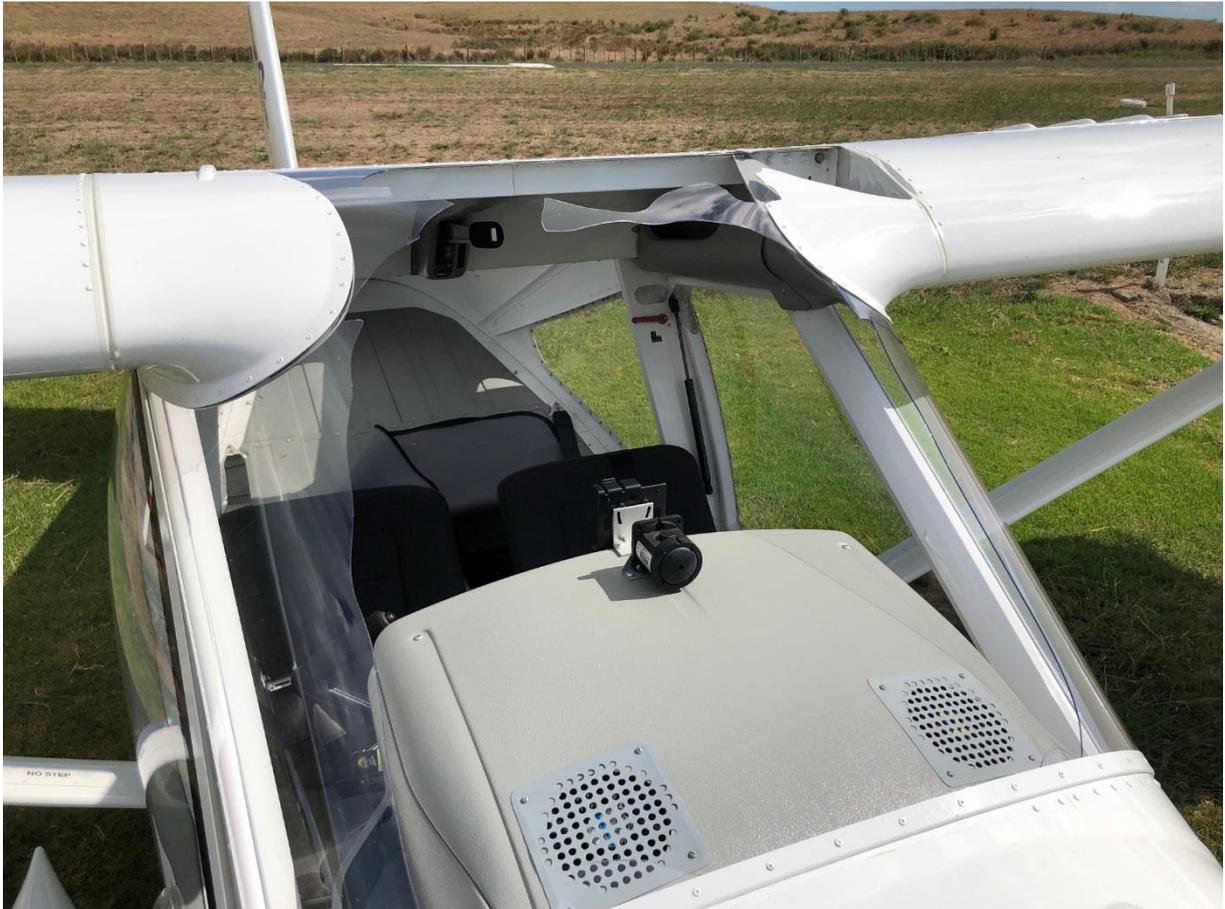
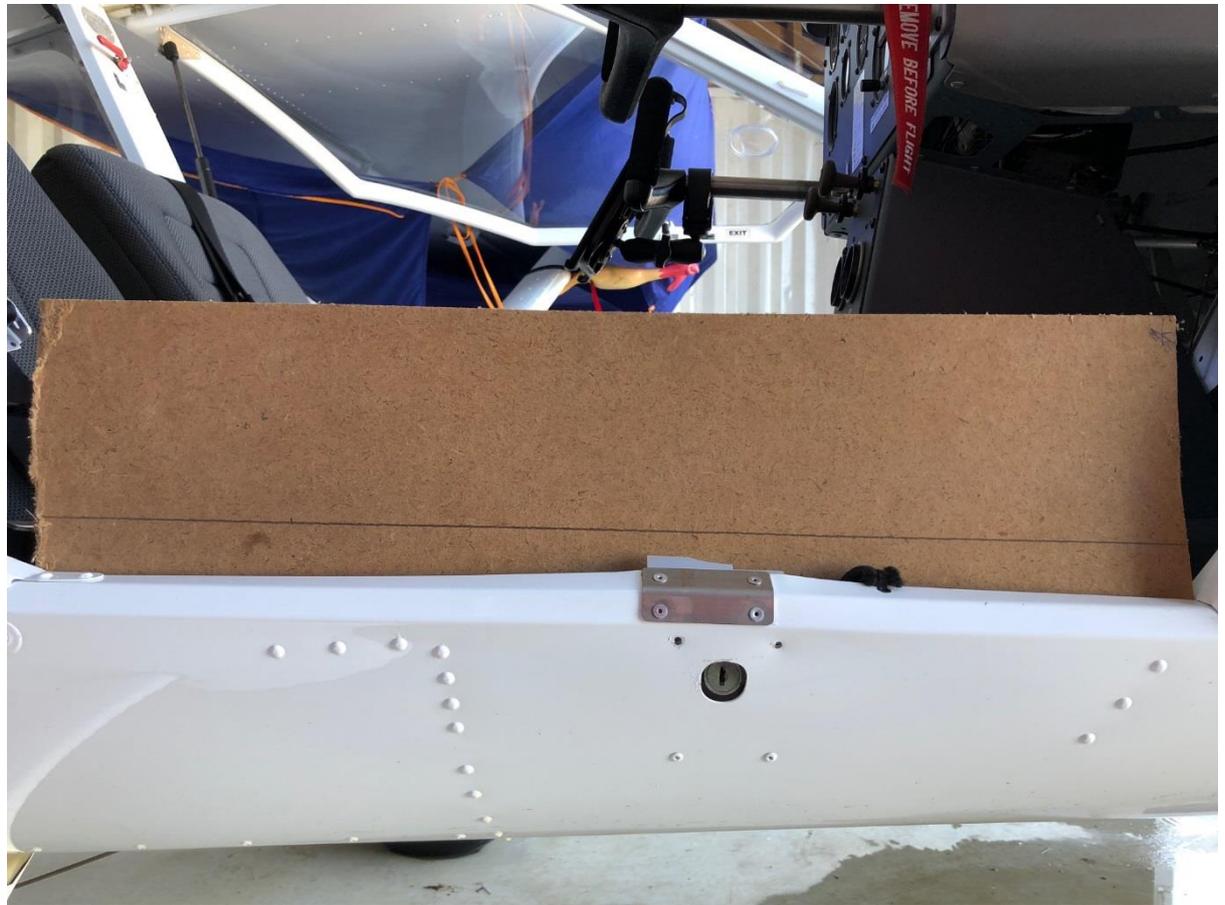
Damage sustained: Except for a few peripheral shards of plexiglass, the entire windshield broke up into many pieces, some remained in the aircraft but most disappeared overboard.

A moulded part of plexiglass of the upper left part of the fuselage was also shattered. This conforms to the leading edge of the left wing and is part of one of the overhead storage receptacles where I would store small items. All of those items were evacuated out of the aircraft.

Both doors appear to have been deformed.

Both door latches and associated aircraft fuselage skin that forms part of the lower horizontal sill were severely deformed due to the sudden and intense rise in cockpit air pressure. 3 out of the 4 rivets (2 per side) had failed to hold the locking mechanism in place. Although the doors were straining at their latches and bulging outwards during flight after the occurrence, the latches fortunately kept them from opening. In flight, I could see a gap of around 40mm around both doors.
