Defect Report CAA

Flapperon Tube failure

CIVIL AVIATION AUTHORITY OF NEW ZEALAND

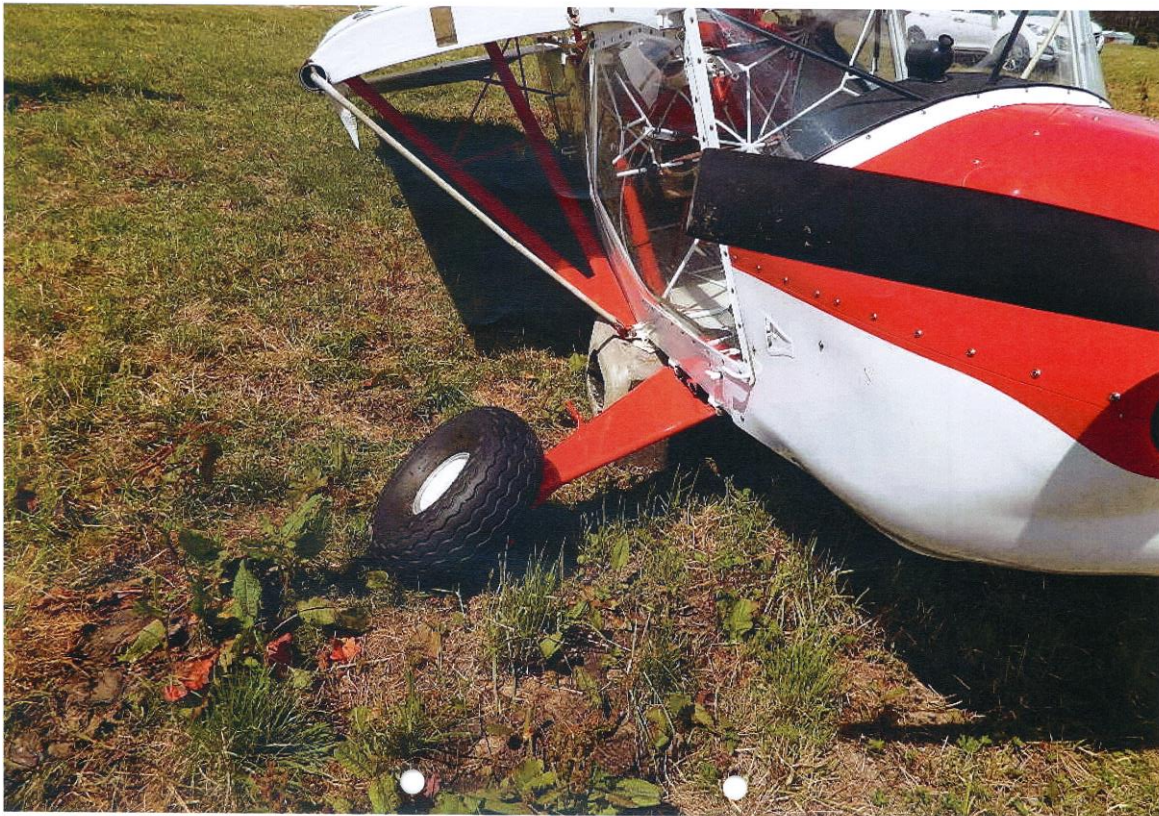
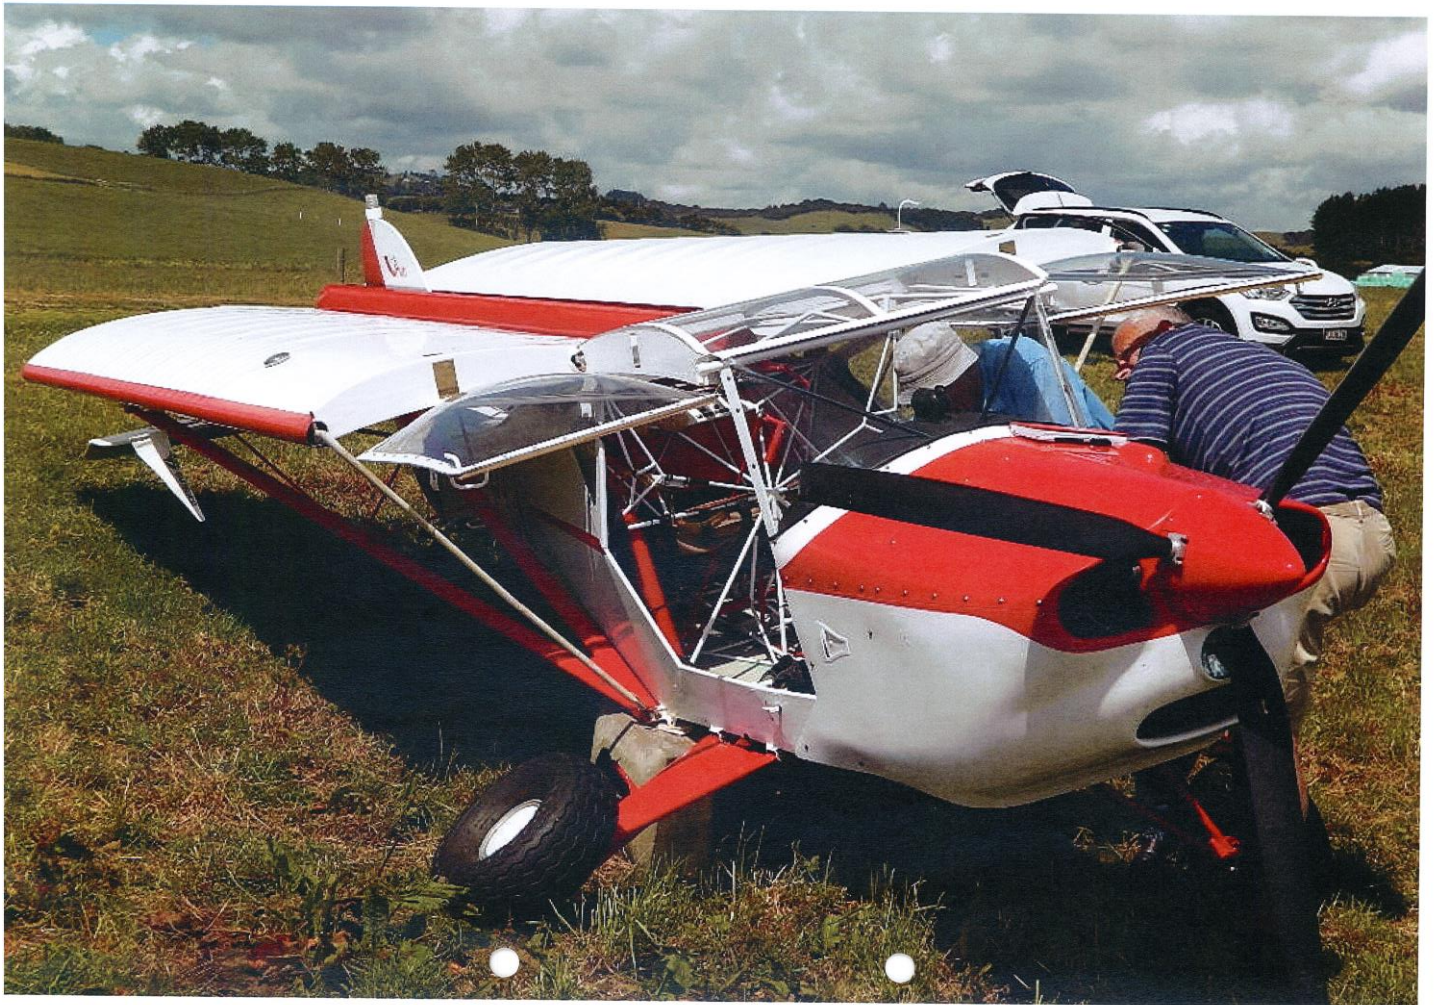
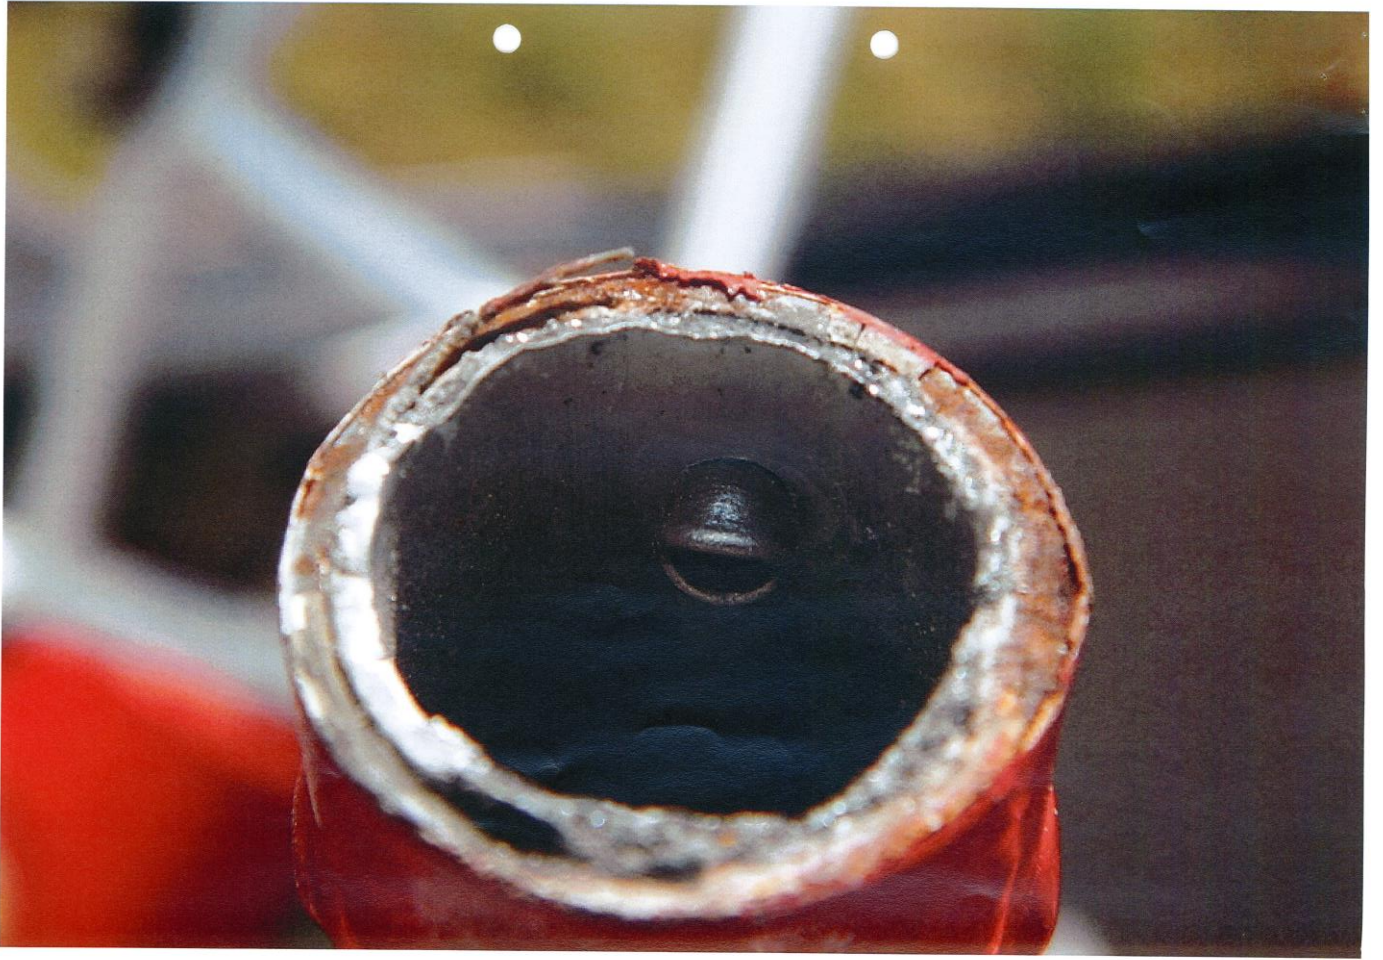
The main aluminium tube which runs the full length of the Flaperon has failed at a point where the Flaperon Lever fits up against the first Flaperon bearing. It would appear that corrosion and fatigue have resulted in the complete inflight failure of the control system.

The main aluminium Flaperon Tube which passes through the entire length of the Flaperon, and extends into the fuselage, allowing the Flaperon Control Lever to be glued and riveted in place. This is a homebuilt aircraft and the Flaperon was supplied from the factory in a full assembled state. The Flaperon Lever is positioned hard up against the first bearing, which is attached to the trailing edge of the wing. The Flaperon Lever is made of 4130 Chrome Molly tube. Over time, moisture has entered the joint between the bearing and the 4130 tube and corrosion or cracking has taken place. The detection of this is not possible when carrying out a normal pre-flight inspection or an annual inspection for a permit to fly. This corrosion has interacted with the aluminium tube to a point that the aluminium tube has failed and the Flaperon Lever has sheared off when on a landing manoeuvre. The right hand wing failed to respond to the control input by the pilot. The aircraft appeared to have stalled due to the immediate loss of flap function on the right hand wing. It remained in a down wing attitude and the aircraft came in contact with the ground causing the aircraft to impact heavily, damaging the undercarriage, propeller, and right hand wing tip. The aircraft rotated 180 degrees and continued to travel some length along the grass runway until it stopped.

CAA, RAANZ, SAC, the Avid chat forum in the USA, as the Avid factory no longer exists. My I.A.
