Sport Aviation Corp Ltd
Microlight Aircraft Defect Report

Sonex -Tail wheel Steering arm screws failed

Microlight Type: SONEX Model: TRI-GEAR

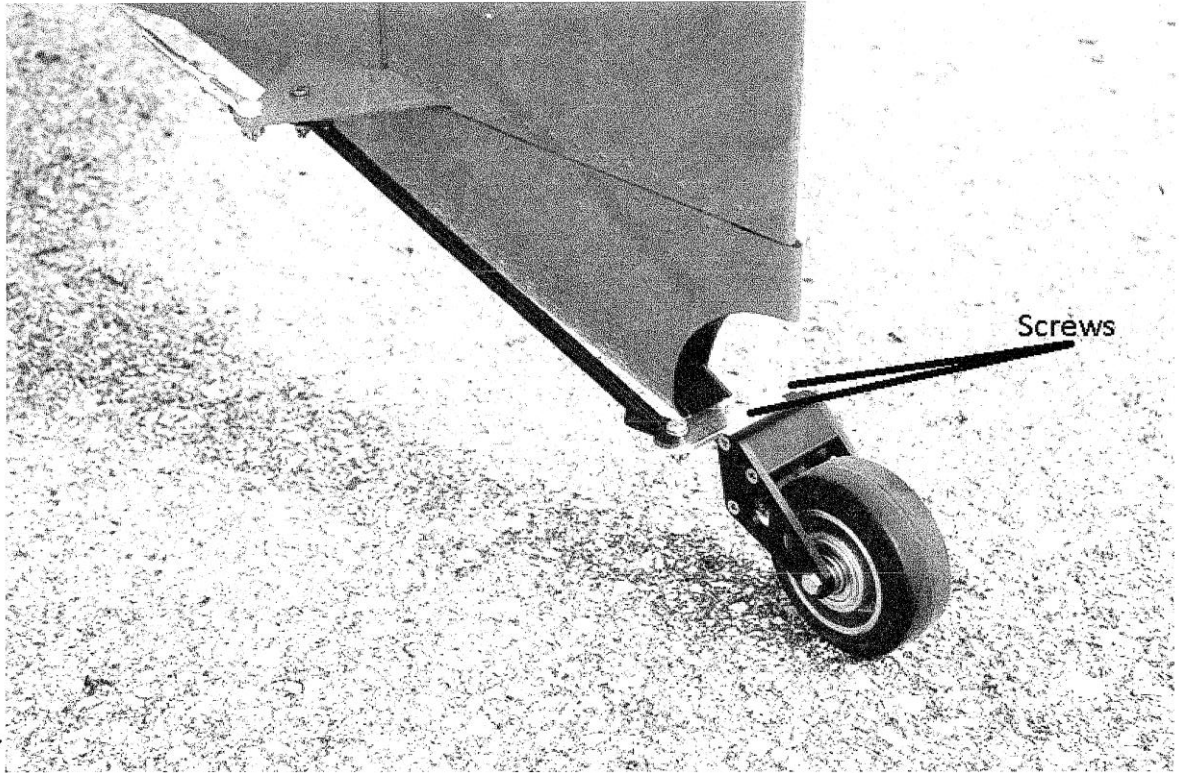
Describe the defect in detail (attach photos and additional info as required): AIRCRAFT WOULD NOT RESPOND TO RODDER CONTROL INPUTS DURING LATER STAGES OF LANDING ROLL. ALSO UNABLE TO TAXI A/C DUE NO STEERING CONTROL. TWO STEERING ARM LOCATING SCREWS FOUND TO HAVE SHEARED OFF ON TAIL WHEEL ASSEMBLY

A/C WOULD NO RESPOND TO RUDER CONTROL INPUTS DURING LATER
STAGE OF LANDING ROLL. A/C COULD NOT BE TAXIED DUE NO STEERING
CONTROL. INSPECTION FOUND TWO LOOSENING SCREWS IN TAIL WHEEL ASST
HAD SHEARED OFF.

ROOT CAUSE OF THE PROBLEM WAS: ~~UNKNOWN~~ UNKNOWN. STANDARD PREFLIGHT HAD
NOT IDENTIFIED ANY ISSUES. FAILURE OF SCREWS COULD HAVE BEEN DUE TO
A NUMBER OF POSSIBLE CONTRIBUTING FACTORS.

Describe remedial action taken and by whom: SHEARED SCREWS REMOVED + REPLACED

THE SAC TECHNICAL OFFICER ONLY - has assessed the above defect, approved remedial action and described below the outcome details for publication. (Add additional info as required)
In communication with Gavin Magill, the reportee, I advised him that a fix could be accomplished by the use of AN or MS Bolts which would have a higher shear loading and more effective in this position,(this.if they could be fitted.)

PREVENTATIVE ACTION REQUIRED TO STOP RECURRENCE: INSPECT SCREWS DURING PREFLIGHT
FOR SECURITY + INTEGRITY. REMOVE + INSPECT SCREWS ANNUALLY
+ REPLACE IF WORN OR SHOWING SIGNS OF FATIGUE.
