## Problem Report

Collision with boundary fence

Tecnam P92 Eaglet

## Runway overrun incident - Jan 2017

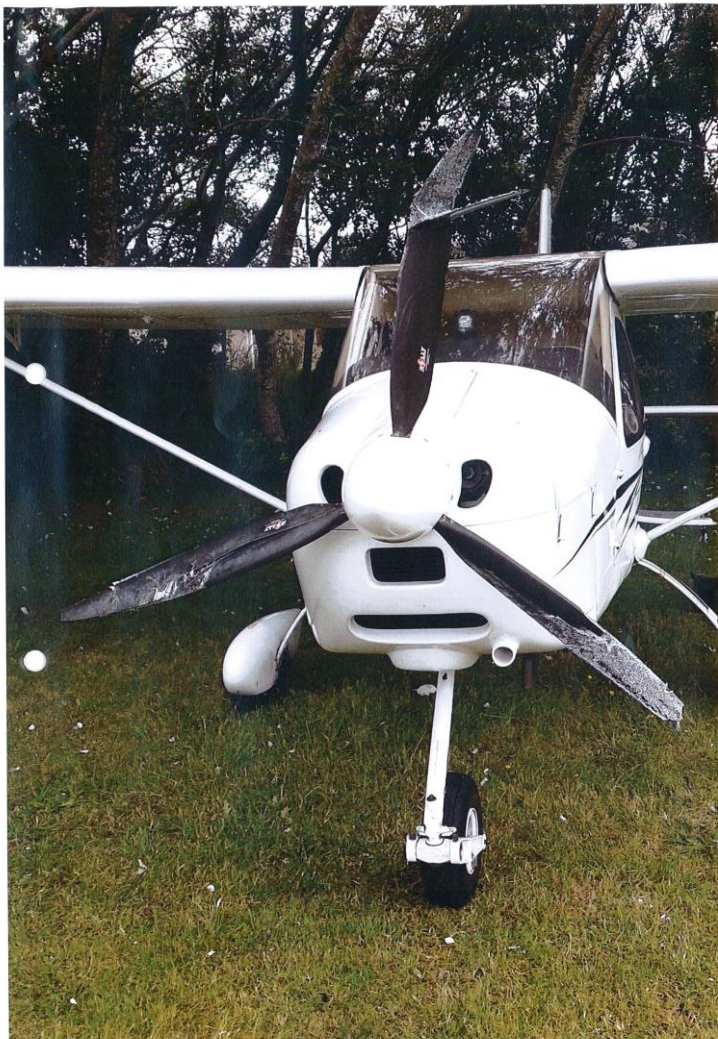
I deduced that 5 knots was negligible and would probably be cancelled out by the uphill gradient of runway 05, so I decided to join left base for 05. On left base I looked for the windsock which is usually on the SW corner but it was not there. When I turned onto final I looked for the windsock at the far end (NE corner). I was looking at it "end on" and it did not look inflated so continued my approach, however the wind at ground level was apparently about 15 kts, to together with my approach speed of 55 kts meant I would be landing at 70 kts (far too fast), but I did not immediately realise the ground speed. I landed smoothly, but too far in and should have gone around, but still thought I had plenty of runway. As soon as I touched down I immediately applied the brakes, but (according to a bystander) the wheels locked up and we slid along on the short dry grass (like skating on ice) and took a long time to slow down (much to my horror!). We hit the fence at the NE end, fairly lightly and the prop wrapped around the fence wire stripping the carbon fibre blades like paper (see photo). The forward impact was not much, we did not hear a bang and our shoulder harness did not tighten. The fence wires and battens were not broken, indicating a light collision.

Mistake No. 1. - Landing downwind!

Mistake No. 2. - Not going around
